# CHURCH GATE CONSERVATION AREA

Draft Character Appraisal

(Draft Revised Church Gate Conservation Area Appraisal, September 2016)

Leicester  
City Council

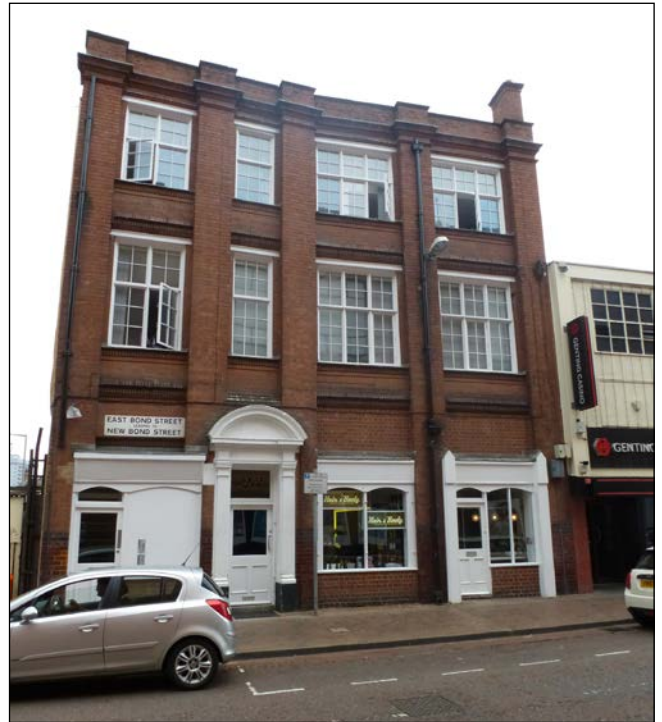
25 East Bond Street: an example of a red-brick former factory now converted to residential and commercial uses.

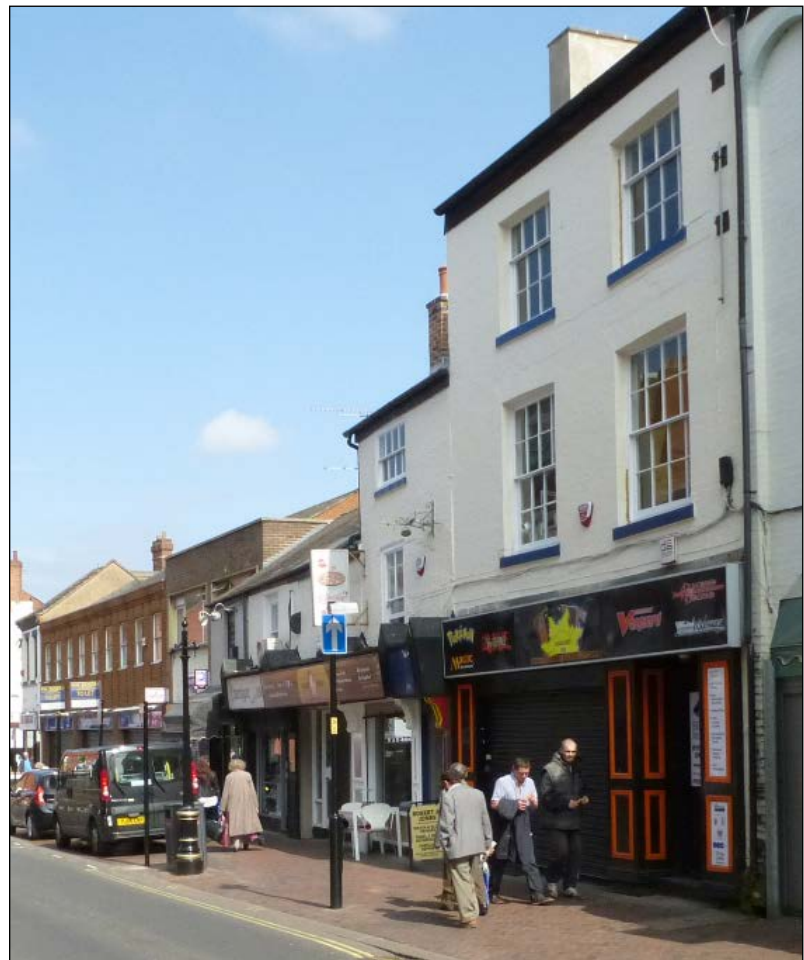
*The restoration of traditional windows to the upper floors of 39-45 Church Gate has helped restore lost character and contributes greatly to the overall character of the area.*

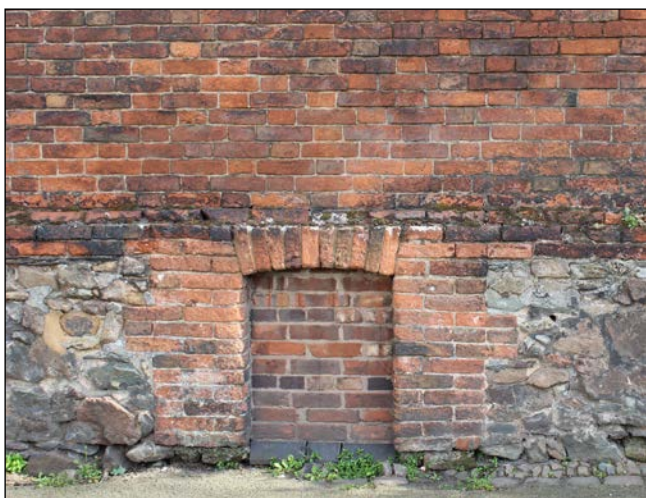
*Brick and Stone detail: Butt Close Lane Wall*

The use of stone as a building material is not typically found within the Conservation Area, although stone detailing is used on some of the grander buildings. The boundary wall to the Great Meeting Hall on Butt Close Lane is an unusual but decorative use of stone, which encapsulates the history of the area. The view of St Margaret's Church looking south means a prominent stone building strongly contributes to the character of the area, without actually being located within it.

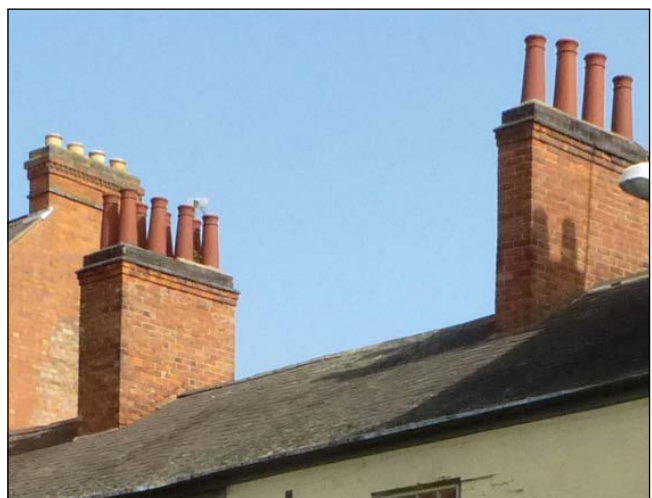
*Chimneys and pots on Church Gate.*

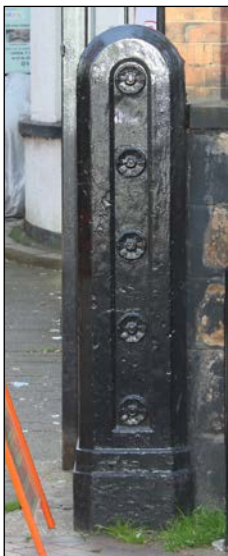
*Cast Iron gate pier at 66 Church Gate.*

Other materials occur in small quantities across the Conservation Area. Stucco is used to great decorative effect on 66 Church Gate. Plastic, in the form of replacement windows, has appeared in some parts of the Conservation Area; however, this is an unsympathetic material, not suitable for a historic area.

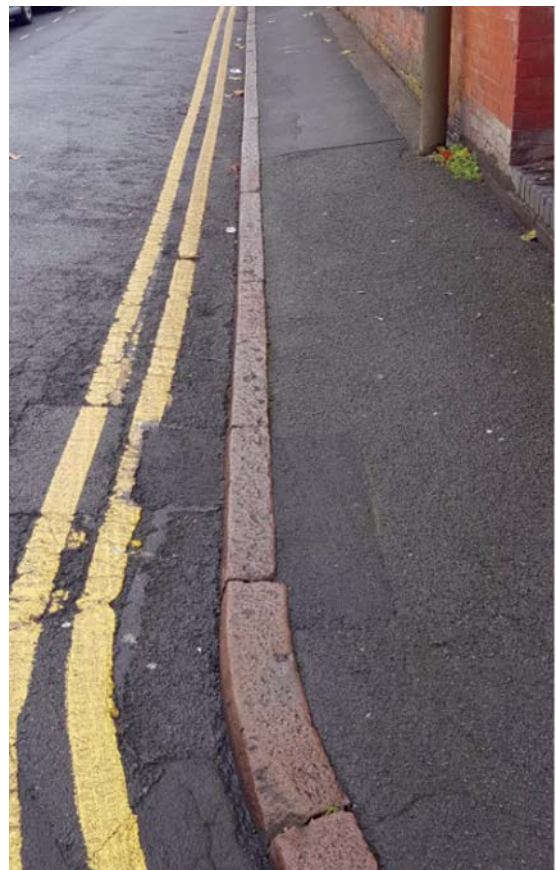
*This Mountsorrel Granite Kerb on Blake Street – provides a strong and characterful edge to the pavement.*

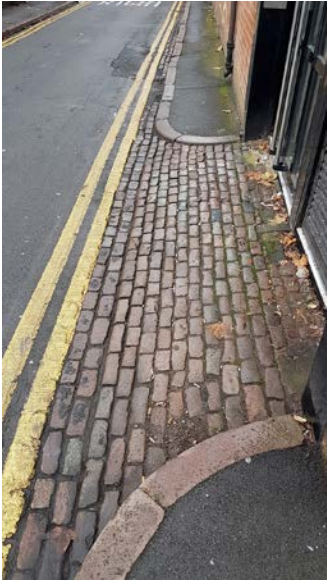
*Far left. Granite setts marking a vehicular entrance on Butt Close Lane.*

In some parts of the area, granite setts have been re-laid out of context in decorative patterns as part of public realm works. Typically, these are in the footway and mark out street furniture such as lamp-posts. Where they are devoid of historic context, setts do not have the same importance.

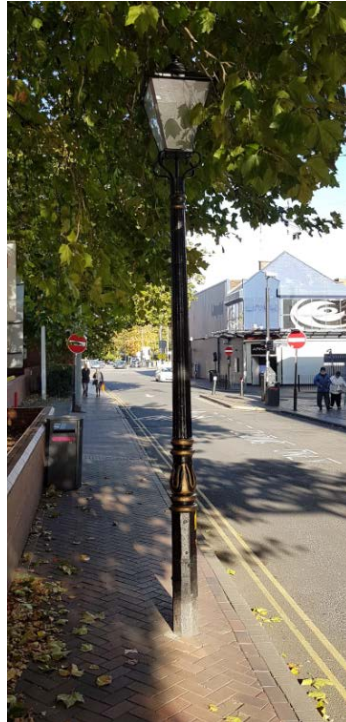
*A 'Wright's Foundry' column on Church gate dating from the mid-19<sup>th</sup> Century and made in a local foundry.*

Pieces were generally commissioned by the Corporation of Leicester from local foundries and are often of a unique bespoke style.

Cast iron is brittle in nature and prone to shatter when struck with a forceful enough blow. It is also heavy to move and relatively inflexible in this respect. As such they have mostly been replaced with more flexible mild steel alternatives.

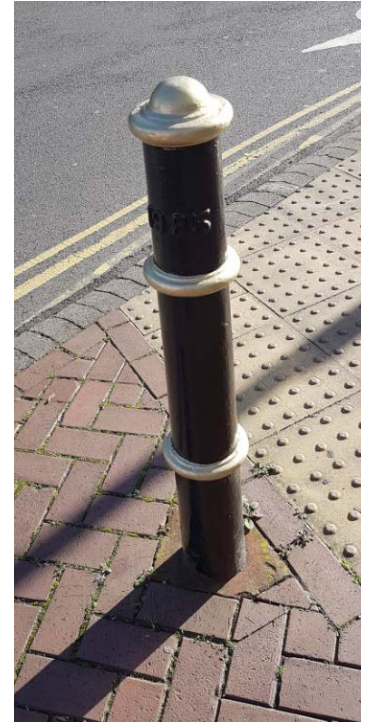
*A cast iron bollard on Church Gate dating from the 1980s.*

Some items of cast-iron or metal street furniture are replicas and date from the late 20th century. These don't have the same intrinsic historic interest but may still add to the character of the area.

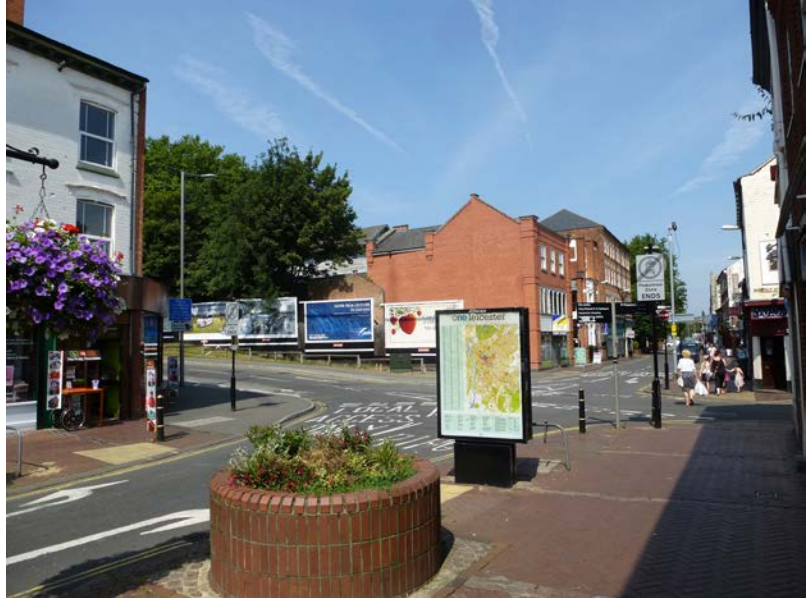
*The 1980s resurfacing remains the predominant surfacing on Church Gate.*

This area was comprehensively re-paved in the mid 1980s as part of an improvement scheme. Red paviours, laid in a herringbone pattern were used for both the carriageway and pavements and raised circular brick planters were used for tree planting. In 2006, the carriageway was replaced with black-top tarmac when the street was modified to accommodate buses. A number of the planters were removed at this time.

The red paviours do not have historic precedent and now have a dated and worn feel and many are now uneven through wear and have been patch-repaired with black tarmac all of which detracts from the character of the area.

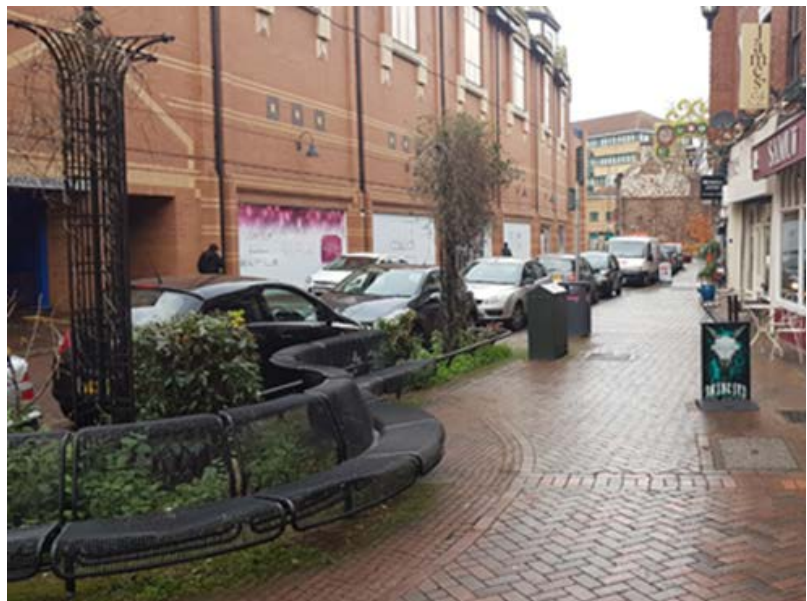
*The 1980s public realm scheme extends to New Bond Street where a seating and planting area is still present. While dated in style it is in a reasonable state of repair.*

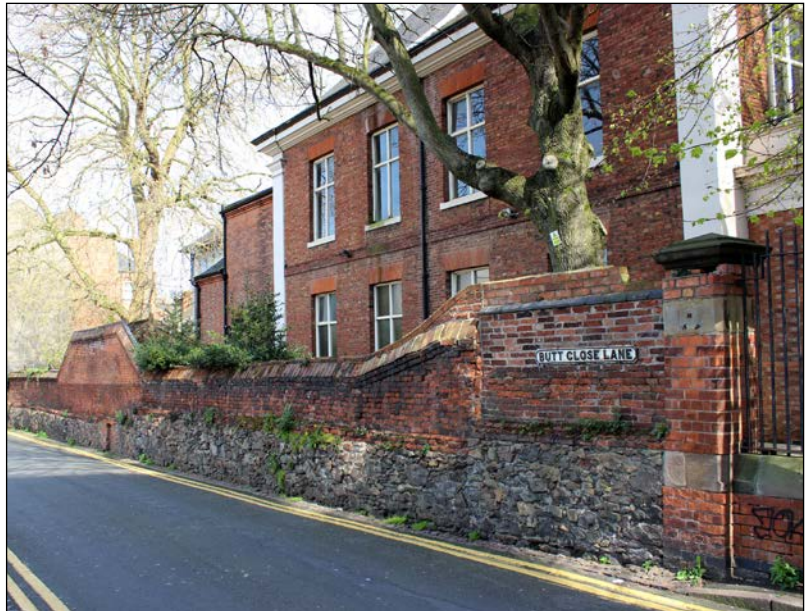
*The boundary wall on Butt Close Lane is made of a of stones and bricks of varied styles and likely dates from the 18th Century.*

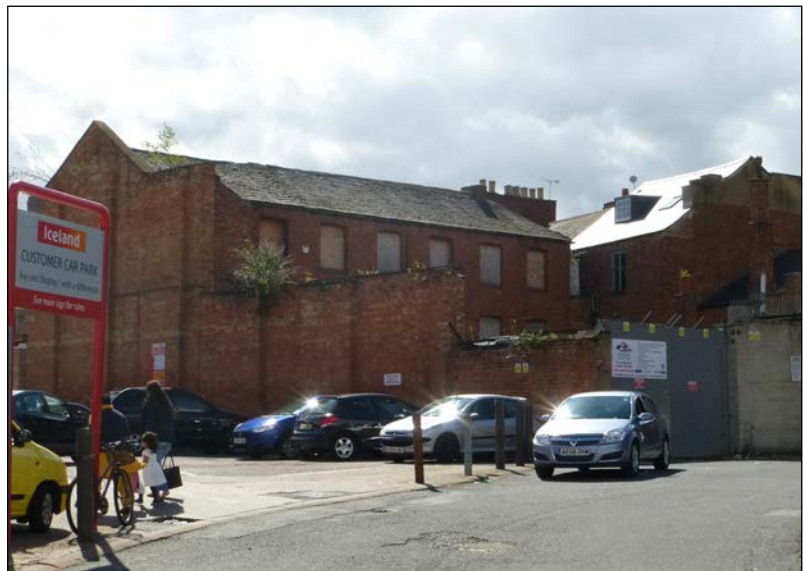
Rear of 39 Church Gate.

7.12 **To the rear of 39 Church Gate** is a substantial three-storey factory building. It is of solid red brick construction with simple arched windows. It is plain in detailing and retains a Swithland slate roof, which is in poor condition. Historic maps indicate it was formerly surrounded by buildings. Wrights directory in 1899 suggests number 39

was in use as an animal preserver and skin dresser; this building may have been used in connection with this business. It can now be viewed from the service yard of the properties on Belgrave Gate (outside the Conservation Area). The building is currently empty and in need of repair and re-use.

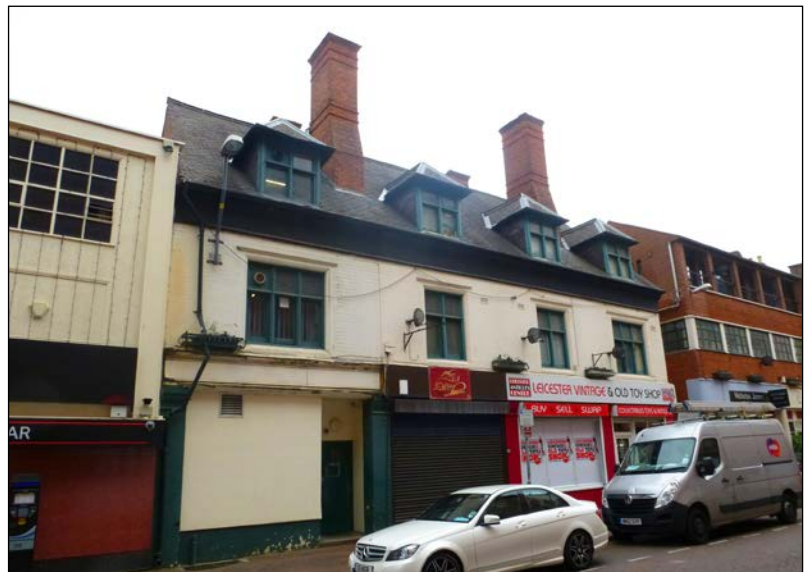
*9-15 East Bond Street retains much original character including prominent chimney stacks and leaded glass – elements of the historic shopfronts survive beneath security features.*

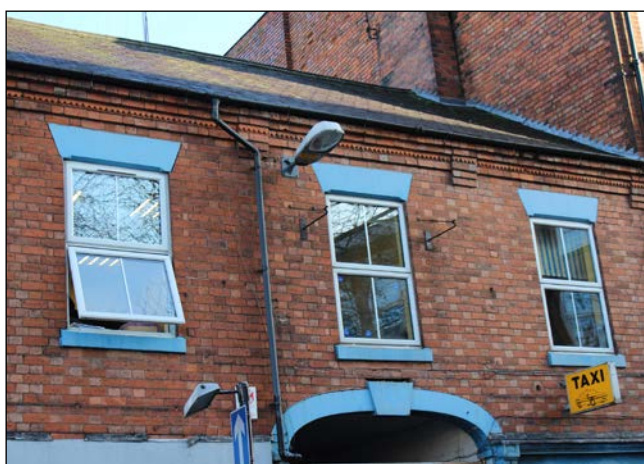
*Inappropriate windows at 79 Church Gate.*

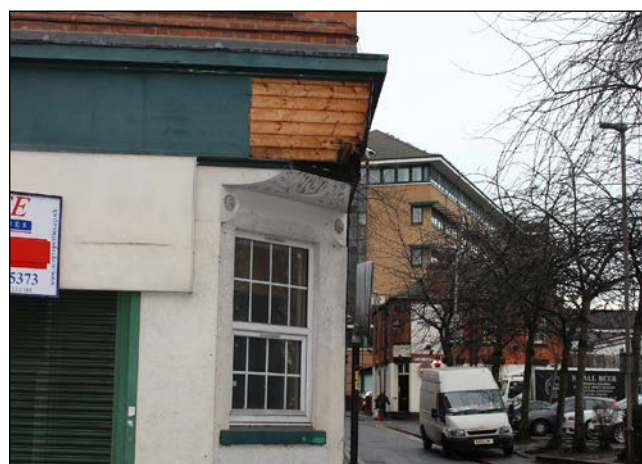
*Obscuring of decorative corner feature at 70 Church Gate.*

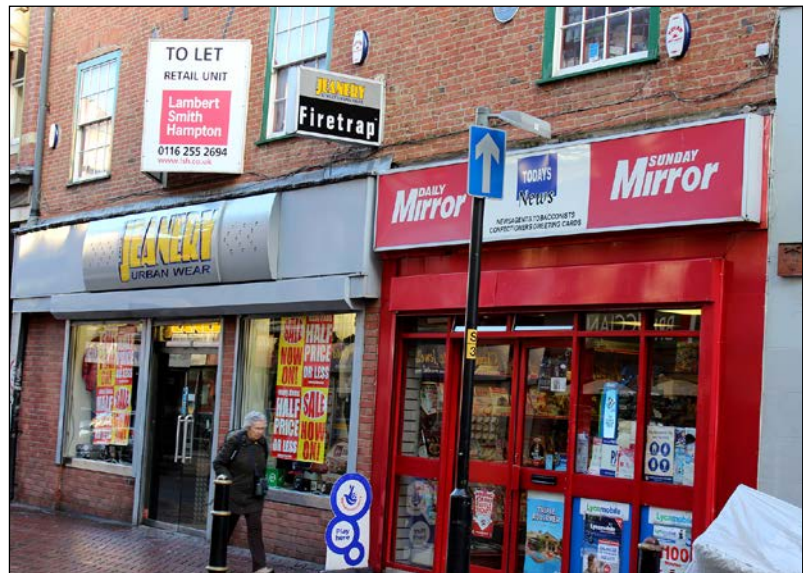
The shopfronts at 9-11 Church Gate don't relate well to the main building to the detriment of the building as a whole.
